Visy's Recycled Paper Mill – Reservoir

Community Update - June 2023

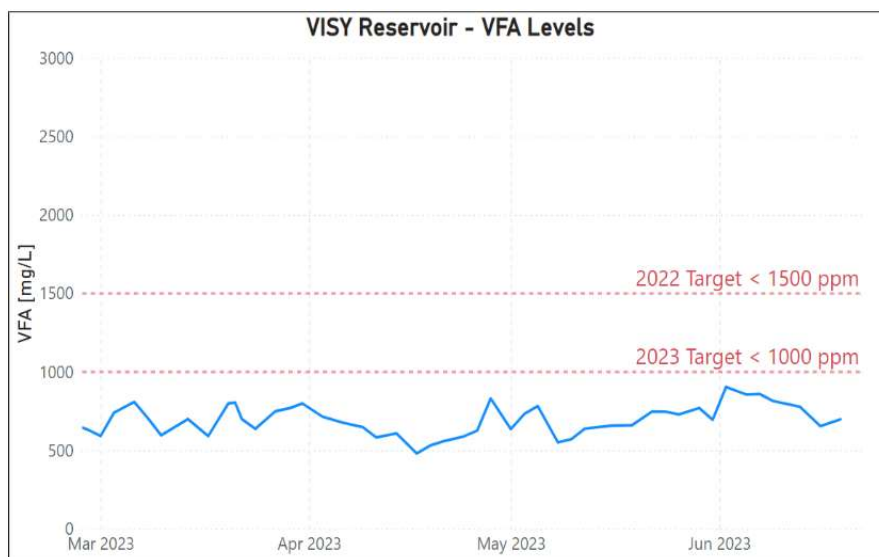
Volatile Fatty Acids (VFAs), a known contributor to bacteria-related odour, and a key measure of the system effectiveness, have remained between 500 – 800ppm, well below the revised target of 1000 ppm

The sanitisation program continues to operate in full effect, comprising of a system that automatically doses chemical biocides into the process at various locations to control odour causing bacteria. Online and manual tests monitoring the presence of known odour-related compounds and other key indicators in the process providing instant feedback on the systems effectiveness.
